Travis County Fire Marshal's Office Case #11-22090 Steiner Ranch Wildland Fire 9/4/2011

Table of Contents Steiner Ranch Wildland Fire

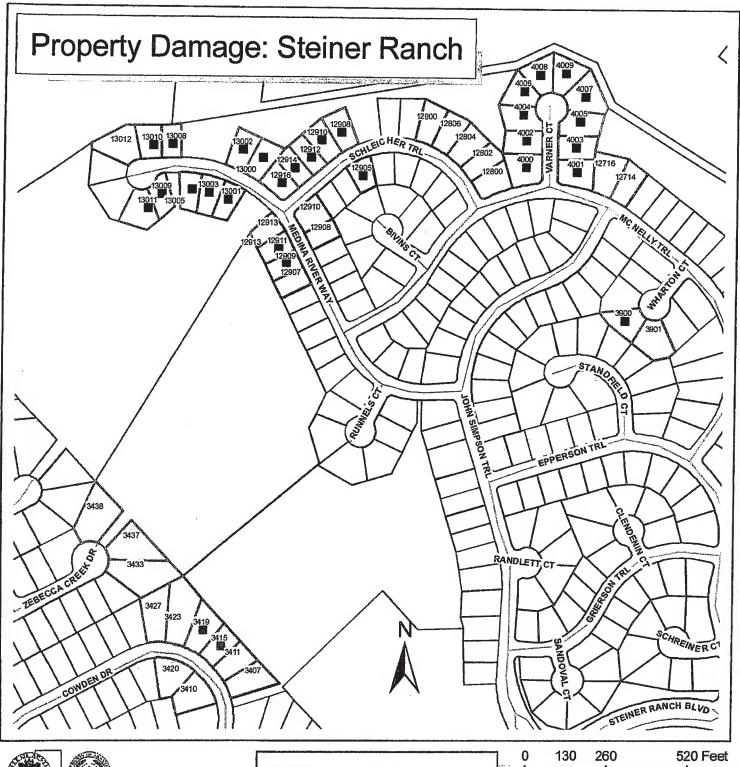
DAMAGE

Total Loss
Partial Damage

Minimal Damage
